Masterton Town Hall Structural Options Report

Report Rev A 13/11/2024 - AGC – Resource Consent

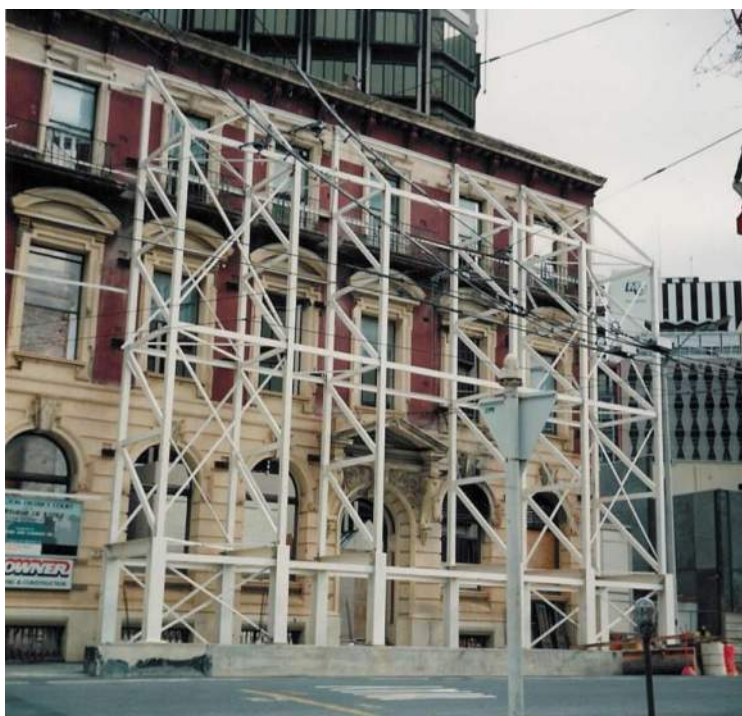
Figure 3.5 - Example of Façade Retention Temporary Works (Wellington District Court)

The façade will require temporary support during the construction of the new building. This would likely consist of a structural steel frame outside the footprint of the site. The temporary works could be placed inside the site, but this may increase the complexity of the construction logistics as the new building is constructed.
